# The Tele-vue Trouble-Shooter

## Instructions for Using

Simply select the Tele-Vue Trouble Shooter Chart by observing the symptom on the TV Receiver and referring to one of the following groups of troubles:

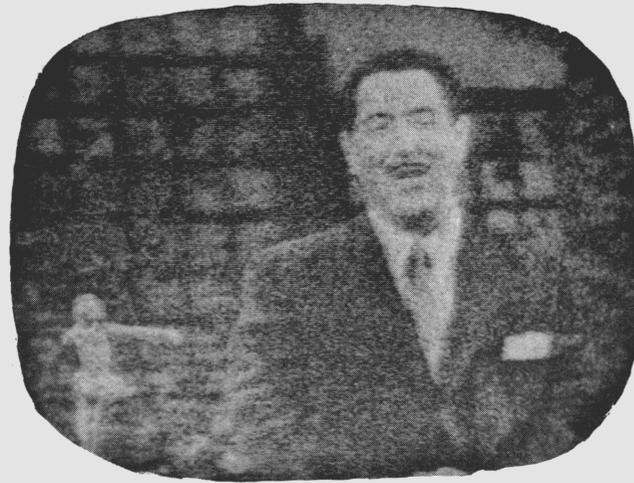
### SNOWY PIX

A SNOWY PIX MUST BE CAUSED BY EITHER THE R. F. AMPLIFIER STAGE OR THE ANTENNA CIRCUIT. IN SOME RARE CASES THE A. G. C. MAY BE TOO GREAT TO THE GRID OF THE R. F. AMPLIFIER IN WHICH CASE TROUBLE-SHOOTING THE A. G. C. WOULD BE NECESSARY. THIS VOLTAGE WOULD HAVE TO EXCEED -6 VOLTS.

IN A VERY WEAK SIGNAL AREA A SNOWY PIX IS NORMAL, IF A SET WAS WORKING NORMALLY, THEN SOME TROUBLE MUST BE SUSPECTED. WHEN THE R. F. AMP. DOES NOT AMPLIFY, DUE TO SOME DEFECT, OR THE INPUT IS VERY WEAK (POOR ANTENNA) NOISE WILL BE STRONG AS THE SIGNAL, AND WILL APPEAR AS A SNOWY EFFECT OVER THE PICTURE.

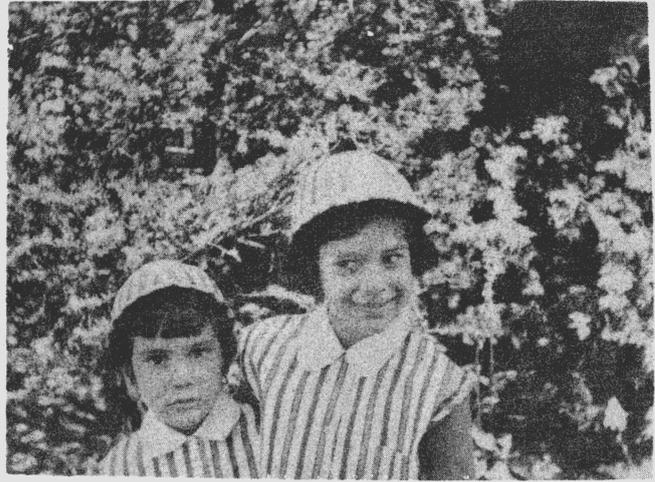
D R I F T I N G

THE CONDITION KNOWN AS DRIFTING CAN BE RECOGNIZED BY THE FADING THAT TAKES PLACE IN THE SOUND AFTER THE TV SET IS SWITCHED ON FOR A FEW MINUTES. THE OUTSTANDING FEATURE OF THIS TROUBLE IS THE FACT THAT A READJUSTMENT OF THE FINE TUNING CONTROL WILL BRING BACK THE SOUND FADING MAY CONTINUE IN THE ABOVE FASHION FOR 10 MINUTES IN SOME CASES-FINE TUNING WILL BRING SOUND BACK EVERY TIME.

THE CAUSE OF DRIFTING IS THE LOCAL OSCILLATOR CIRCUIT. AS THE TV SET WARMS UP SOME COMPONENT CHANGES VALUE. THIS IN TURN CAUSES THE LOCAL OSCILLATOR TO CHANGE FREQUENCY SLIGHTLY. SINCE THE SOUND IS MOST CRITICAL IN TV A SLIGHT CHANGE IN LOCAL OSCILLATOR FREQUENCY WILL AFFECT THE SOUND WITHOUT ANY NOTICEABLE EFFECT ON THE PICTURE. THIS CONDITION IS FOUND MAINLY IN SPLIT CARRIER RECEIVERS.

In the tuner schematic shown this would be C1 and C2. Replace both.

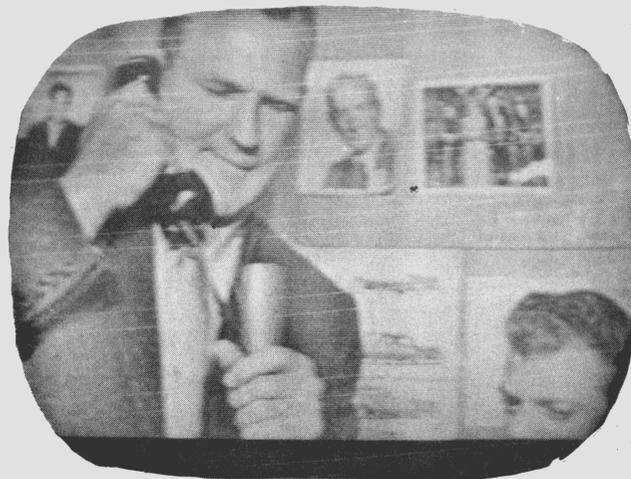
THIS TROUBLE IS A VERY MISLEADING ONE BECAUSE THE TROUBLE APPEARS TO BE IN THE VERTICAL CIRCUIT. HOWEVER, WE FIND THIS TROUBLE TO BE IN VIDEO AMP. OR IN THE SYNC CIRCUIT. IN MOST CASES A DECREASE IN COUPLING CAPACITOR IS THE TROUBLE, OR SOMETIMES AND OPEN 4.5 MC TRAP COIL. THE SCOPE IS A MUST IN QUICKLY FINDING THIS CONDITION SINCE WE CAN SEE EXACTLY WHERE THE TROUBLE IS OCCURRING.

VERTICAL PHASING OCCURS WHEN THE VERTICAL SYNC PULSE IS OUT OF PHASE WITH THE ORIGINAL VERTICAL SYNC PULSE SENT FROM THE TRANSMITTER. THIS WILL HAPPEN IF THE 60 CPS SYNC IS PASSED THROUGH A SMALL CAP. BEFORE THE SYNC TAKE OFF POINT OR WHILE PASSING TO THE SYNC OUTPUT CIRCUIT. THIS TROUBLE WILL NOT BE CAUSED BEFORE THE VIDEO DETECTOR. PICTURE IS LOCKED IN AT THIS POINT ON SCREEN AND USUALLY RETRACE LINES ARE NOTICED.

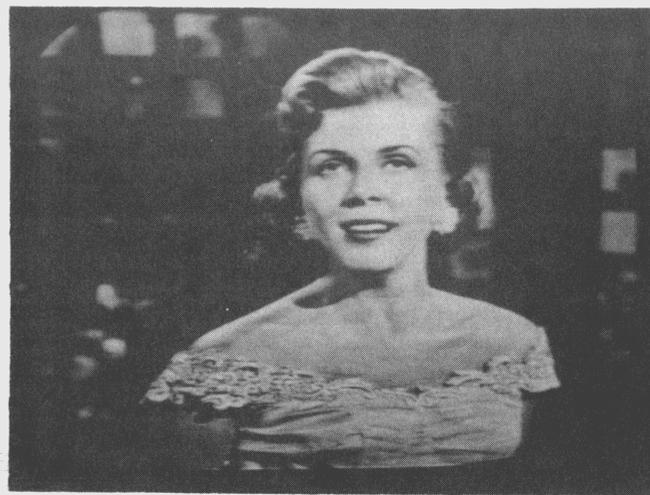
VERY DARK PIX

A PIX THAT IS TOO DARK CAN BE JUST AS BAD AS A PIX THAT IS VERY WEAK. UNDER THIS CONDITION THE PIX BECOMES TOO CONTRASTY AND THE DIFFERENT SHADES DO NOT STAND OUT AS WELL AS THEY SHOULD IN MOST GOOD OPERATING SETS. WHEN THE CONTRAST IS AT A MAXIMUM THE PIX SHOULD BE TOO DARK TO WATCH. IN SOME CASES THE A.G.C. CONTROL MAY BE SET INCORRECTLY, THIS SHOULD BE CHECKED FIRST. NOT ALL SETS HAVE AN A.G.C. CONTROL.

TOO DARK A PIX CAN BE CAUSED BY INCORRECT CONTRAST SETTING, OR A.G.C. CONTROL SETTING. THIS SHOULD BE CHECKED FIRST SINCE THIS IS THE EASIEST THING TO CHECK. TUBES MAY ALSO BE INTERNALLY SHORTED CAUSING MAXIMUM GAIN AS THE SIGNAL PASSES THROUGH IT. THESE MUST BE CHECKED BY REPLACEMENT. ALIGNMENT COULD ALSO CAUSE THIS TROUBLE BUT THIS SHOULD ONLY BE SUSPECTED IF THE SET HAS BEEN TAMPERED WITH.

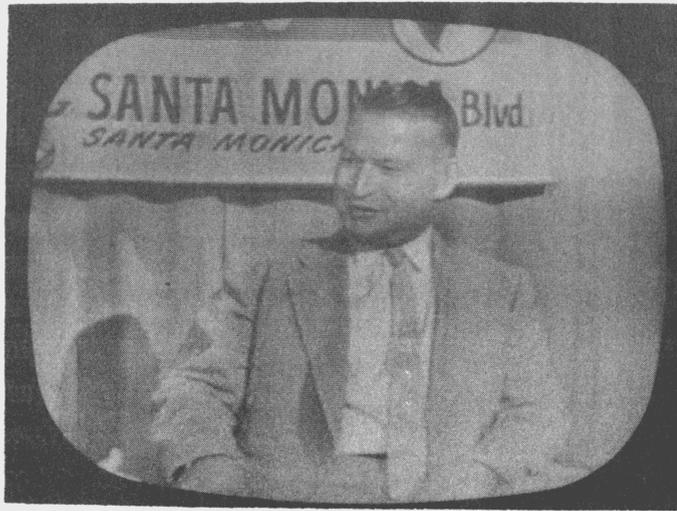
PIX BRIGHT - NO CONTROL

THIS IS AN IMMEDIATE INDICATION THAT THE PIX TUBE IS BAD. ALTHOUGH IN SOME CASES A BAD BRIGHTNESS CONTROL COULD CAUSE THIS CONDITION. IT WILL BE NOTICED THAT IF THE BRIGHTNESS CONTROL DOES AFFECT THE PIX, THAT IT WILL NOT CAUSE THE RASTER TO DISAPPEAR AS FOUND UNDER NORMAL OPERATING CONDITIONS.

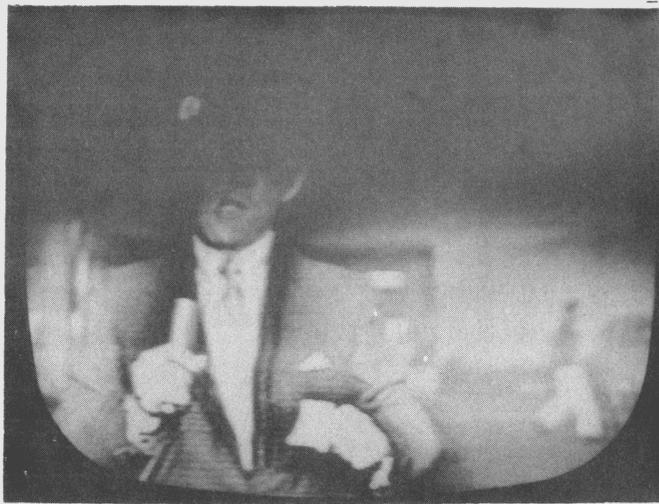
BLACK BAR ON C.R.T.

IN THE CONDITION OF ONE BLACK BAR THE TROUBLE IS A SHORT BETWEEN HEATER AND CATHODE OF ANY VIDEO TUBE. WITH TWO BLACK BARS THE TROUBLE IS AN OPEN FILTER IN THE POWER SUPPLY SINCE TWO BARS INDICATE 120 CPS AND THIS IS FOUND ONLY IN THE POWER SUPPLY.

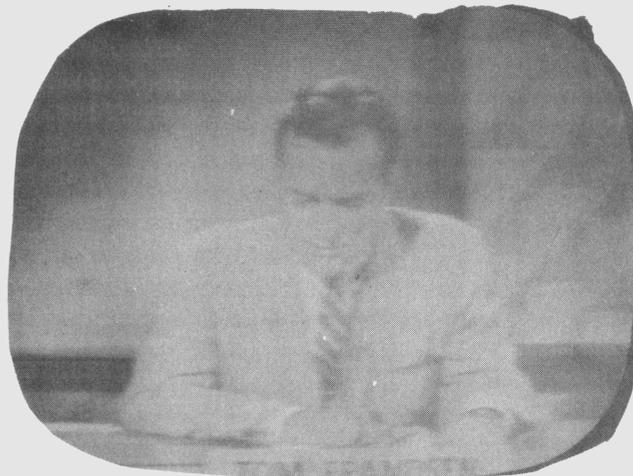
A WEAK RASTER IS A VERY COMMON TROUBLE IN TV SETS. THE CAUSES ARE MAINLY A WEAK CRT OR NOT ENOUGH HV. IF A WEAK CRT IS THE TROUBLE, THEN THE CRT SHOULD BE REPLACED. A NUMBER OF CRT BRIGHTNERS ARE ON THE MARKET THAN CAN RESTORE THE CRT TO A FAIRLY NORMAL CONDITION, BUT IN MOST CASES IT SHOULD BE MENTIONED TO THE CUSTOMER THAT THIS IS A TEMPORARY MEASURE AND THAT THE PIX MAY BE WEAK AGAIN IN A FEW MONTHS AT THE MOST. IN ALL CASES IT IS FAR BETTER TO REPLACE THE CRT.

THE CAUSE OF A CRT BECOMING WEAK IS LOW EMISSION OF THE ELECTRONS IN THE CRT ITSELF. THIS IS CAUSED BY A COATING THAT FORMS ON THE CATHODE OF THE CRT THAT CUTS DOWN ON THE ELECTRON FLOW IN THE TUBE. A CRT BRIGHTNER GIVES A SLIGHTLY HIGHER HEATER VOLTAGE TO THE TUBE WHICH OF COURSE WILL INCREASE THE ELECTRON FLOW IN THE TUBE. IF THE CAUSE OF A WEAK RASTER IS LOW HV AND A BRIGHTNER OR BOOSTER AS IT IS CALLED IS USED THEN THE RASTER WILL GET BRIGHTER WITHOUT CURING THE TROUBLE.

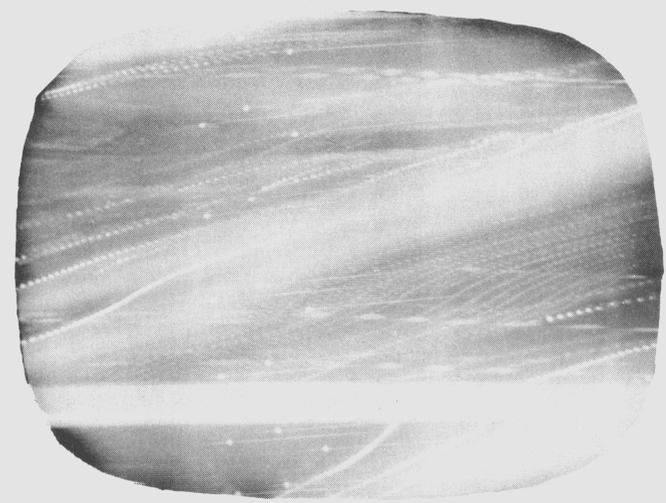
ROLLING-TEARING NEGATIVE PIX

THIS TROUBLE IS COMMON IN CIRCUITS WHERE SEPARATE A. G. C. TUBES ARE USED AS IN KEYED A. G. C. CIRCUITS. TROUBLE CAN BE RECOGNIZED BY NEGATIVE PICTURE. THIS SHOWS EVERYTHING THAT SHOULD BE WHITE AS BLACK AND EVERYTHING BLACK SHOWS WHITE. THIS WILL ALWAYS BE ACCOMPANIED BY ROLLING AND TEARING AS IN LOSS OF SYNC. NOTE THAT BLANKING BAR IS WHITE INSTEAD OF BLACK.

WITH COMPLETE LOSS OF A. G. C. VOLTAGE THE R. F. AMP. AND VIDEO I. F. TUBES ARE AMPLIFYING WITH MAXIMUM GAIN. THIS WILL CAUSE THE I. F. STAGES TO DETECT THE SIGNAL BEFORE THE DETECTOR AND THE RESULT IS A SIGNAL OF OPPOSITE POLARITY AT THE DETECTOR OUTPUT. THIS WILL ALSO CAUSE NO SYNC. DUE TO WRONG POLARITY OF SYNC PULSE, THUS ROLLING, TEARING & A NEGATIVE PIX.

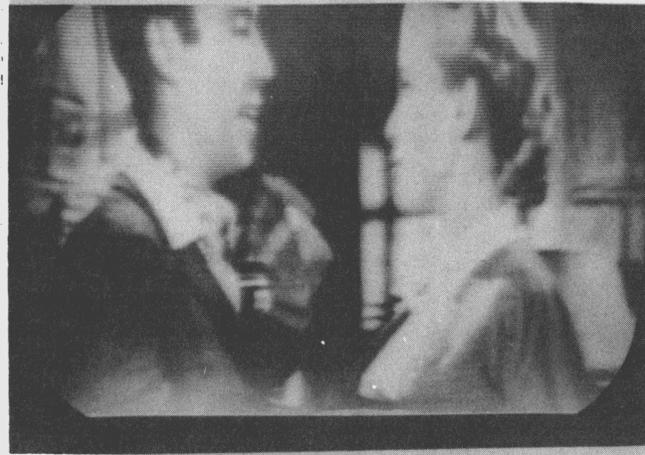
FOLDOVER AT  
BOTTOM OF PICTURE

THE USE OF THE OSCILLOSCOPE IN FINDING THIS TROUBLE IS VERY HELPFUL SINCE THE SAWTOOTH WILL HAVE A FLAT TOP TO IT. BY OBSERVING THE SIGNAL AT THE GRID OF THE VERTICAL OUTPUT TUBE, WE CAN SEE IF THE TROUBLE IS BEFORE, OR AFTER THIS POINT. IF IT IS BEFORE THIS POINT THEN THE SAWTOOTH WILL HAVE A FLAT TOP TO IT AT THE GRID, AND THE VERTICAL OSCILLATOR CIRCUIT MUST BE DEFECTIVE AND CAUSING FOLDOVER.

WHEN THIS CONDITION IS NOTICED THE VERTICAL HEIGHT AND VERTICAL LINEARITY CONTROLS SHOULD BE ADJUSTED TO SEE IF THE WHITE LINE, AT THE BOTTOM OF THE PICTURE CAN BE ELIMINATED. ONE THING IS IMPORTANT AT THIS TIME THAT IS IF THE HEIGHT CONTROL IS INCREASED WAY BEYOND NORMAL, THEN THE FOLDOVER WILL BE WAY BELOW THE SCREEN, BUT THE TROUBLE WILL NOT BE ELIMINATED ONLY COMPENSATED FOR, AND THE TROUBLE WILL RE-APPEAR AS TIME GOES BY.

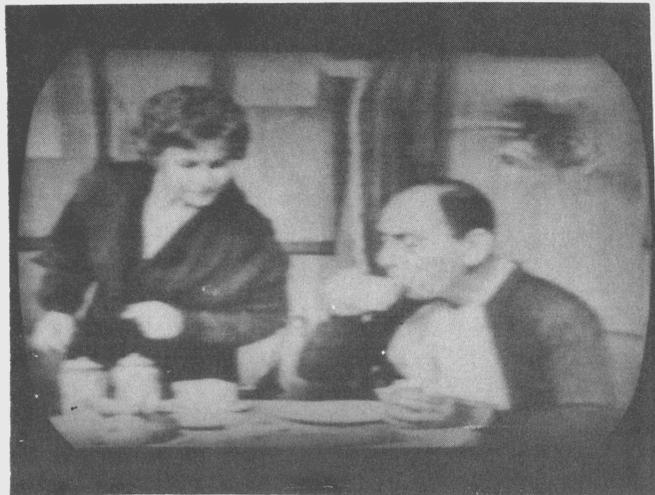
NOT ENOUGH HEIGHT

AMONG THE MOST COMMON TROUBLES OF THIS CONDITION ARE TUBES. THE VERTICAL OUTPUT TRANSFORMER OR YOKE WILL ALSO CAUSE THIS TROUBLE ALONG WITH MANY SMALLER PARTS. THE SCOPE IS A GREAT HELP IN FINDING THIS TROUBLE SINCE WE CAN SEE THE SIZE OF THE SIGNAL AT ANY GIVEN POINT. ONCE THE TROUBLE IS LOCALIZED TO ONE STAGE, THE VTVM CAN BE USED TO FIND THE BAD PART. A CHECK SHOULD BE MADE TO SEE IF THERE IS ENOUGH WIDTH, SINCE LACK OF HEIGHT AND WIDTH INDICATE B + TROUBLE.

IN MOST TELEVISION RECEIVERS THE VERTICAL HEIGHT CONTROL SHOULD BE CAPABLE OF MAKING THE PICTURE GO WAY BEYOND THE TOP AND BOTTOM OF THE SCREEN. WHEN ADJUSTED CORRECTLY, THE TOP AND BOTTOM OF A TEST PATTERN OUTER CIRCLE SHOULD JUST GO BEYOND THE EDGES OF THE SCREEN. WITH NOT ENOUGH HEIGHT, THE PICTURE WILL NOT TOUCH THE SCREEN TOP OR BOTTOM EVEN WHEN THE CONTROLS ARE SET AT MAXIMUM.

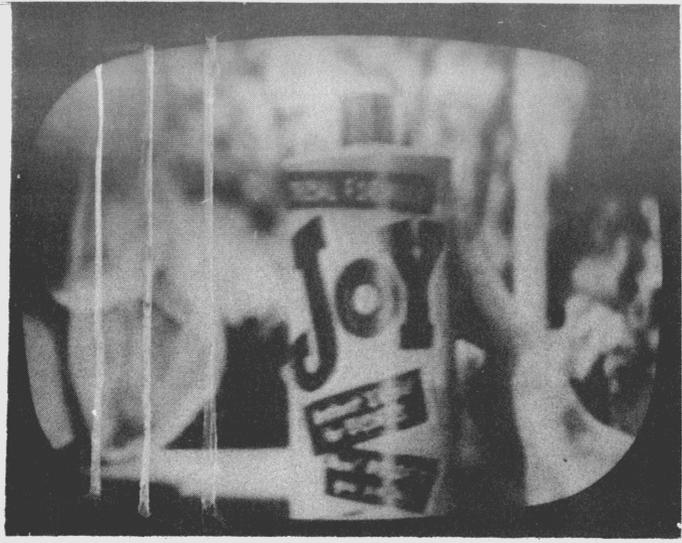
WHITE LINES ON RASTER

MANY TIMES THE DAMPER CIRCUIT IS AT FAULT SINCE IT CONTROLS THE SWEEP ON THE FIRST THIRD OF THE SCREEN IF POOR DAMPING IS OCCURRING THE UNWANTED OSCILLATIONS OCCUR IN THE HORIZONTAL SWEEP CIRCUITS AND THE RESULT IS WHITE LINES ON THE LEFT SIDE OF THE SCREEN. TOO MUCH SIGNAL TO THE HORIZONTAL OUTPUT TUBE WILL ALSO CAUSE WHITE LINES ABOUT ONE THIRD WAY IN FRONT LEFT SIDE OF SCREEN.

IN SOME CASES THESE WHITE LINES ON THE LEFT SIDE OF THE RASTER MAY BE VERY BRIGHT OR HARDLY NOTICEABLE THE HORIZONTAL DRIVE CONTROL SHOULD ALWAYS BE CHECKED FIRST FOR CORRECT SETTING SINCE IT WILL CAUSE THESE LINES TO APPEAR THE CORRECT SETTING OF THE DRIVE CONTROL IS WHEN IT IS AT A POINT JUST BEFORE WHITE LINES ARE NOTICED ON THE SCREEN.

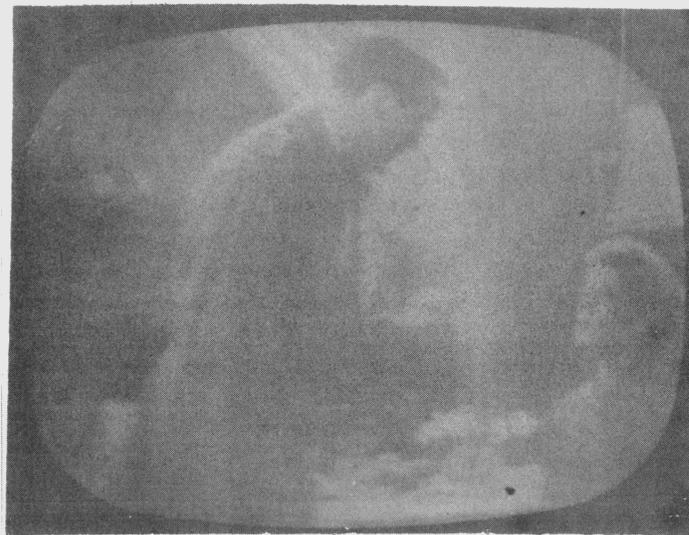
LOW H. V.

IF A LOW AMOUNT OF HV IS APPLIED TO THE SECOND ANODE OF THE CRT THE RASTER WILL BE WEAK BECAUSE THE FORCE OF THE ELECTRON BEAM STRIKING THE PHOSPHOR SCREEN WILL NOT BE STRONG ENOUGH TO ILLUMINATE THE SCREEN TO

THE CORRECT BRIGHTNESS- THE CAUSE OF BLOOMING ALONG WITH A WEAK RASTER WILL OCCUR BECAUSE THE SMALL AMOUNT OF CURRENT FLOWING THROUGH THE HV CIRCUIT WILL DROP THE HV EVEN MORE AND IN SEVERE CONDITIONS THE HV WILL DROP TO A POINT WHERE IT WILL NOT BE ENOUGH TO LIGHT THE CRT AT ALL.

LOW H.V. WILL USUALLY CAUSE A WEAK RASTER TO BE ON THE CRT. AND IN MANY CASES WILL BE CAUSING BLOOMING. THIS CONDITION MAKES THE RASTER SEEM TO SWELL OUT AS THE BRIGHTNESS CONTROL IS INCREASED. THIS CONDITION MAY BECOME SO BAD THAT THE RASTER WILL COMPLETELY FADE OUT. SOME SIMPLE CHECKS WILL SOON TELL IF THE HV IS AT FAULT, AND IF SO TUBE SUBSTITUTION AND VOLTAGE CHECKS WILL IN MOST CASES LOCATE THE TROUBLE. A DEFECTIVE CRT WILL GIVE THE SAME CONDITION AS LOW HV.

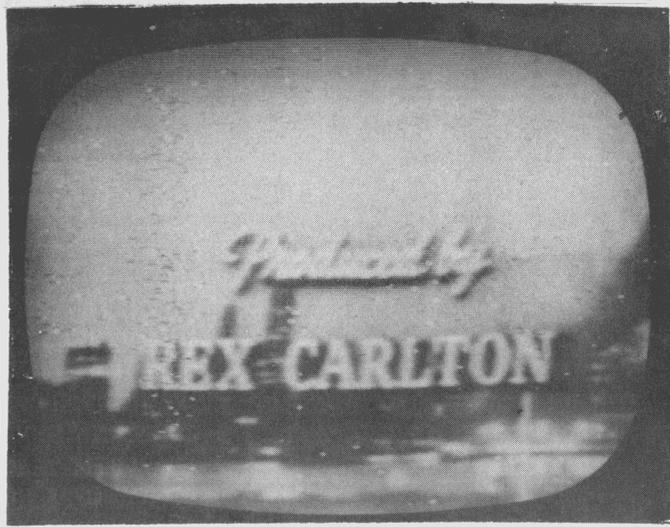
H. V. A R C I N G

HV ARCING USUALLY OCCURS AT THE BASE OF THE HV RECT. OR IN THE FLYBACK ITSELF AND IN ORDER TO SEE THE ARCING IT MAY BE NECESSARY TO TAKE THE SET INTO A COMPLETELY DARK ROOM AND WATCH THE HV SECTION. THERE ARE MANY HV SPRAYS ON THE MARKET THAT MAY BE USED TO CLEAR UP THIS TROUBLE BUT IN MOST CASES IT HAS BEEN FOUND THAT TO REPLACE THE DEFECTIVE PART IS BY FAR THE BEST SOLUTION. DUST, DIRT, AND POOR INSULATION ARE THE MOST COMMON CAUSES OF THIS TROUBLE.

VERY OFTEN HV ARCING OCCURS IN TV RECEIVERS. THIS ARCING WILL OCCUR MORE OFTEN IN THE SUMMER TIME DUE TO THE HUMIDITY IN MANY AREAS. THE ARCING MAY BE NOTICED AS THE SET IS FIRST SWITCHED ON OR DURING THE TIME THE SET IS PLAYING. ARCING MAY REMAIN DURING THE ENTIRE TIME THE SET IS ON AND WILL CAUSE A NUMBER OF FLASHES TO CONTINUALLY BE SEEN ON THE SCREEN, THIS IS VERY ANNOYING TO THE CUSTOMER AND THE SET SHOULD BE CHECKED CAREFULLY FOR THIS TROUBLE BEFORE SENDING BACK AS A FINISHED JOB.

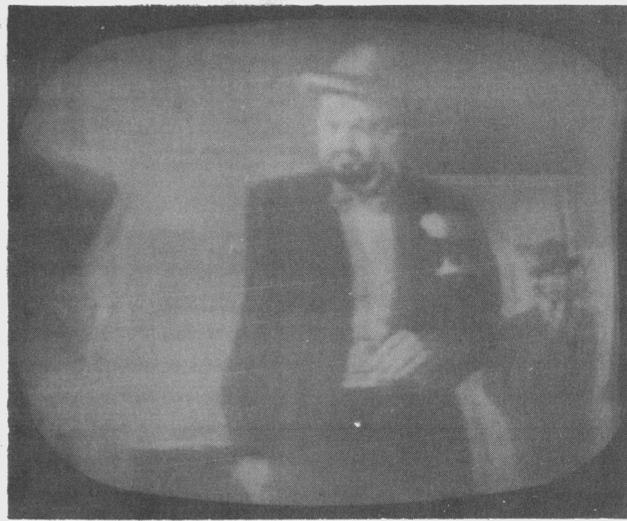
120 C.P.S. PULL

IN A FULL WAVE RECTIFIER CIRCUIT THE INPUT FREQUENCY IS DOUBLED BY THE RECTIFYING ACTION IN THE POWER SUPPLY. WITH A 60 CYCLE INPUT TO THE POWER SUPPLY OF A TV SET WE WILL END UP WITH 120 CYCLE OUTPUT. IF POOR FILTERING IS TAKING PLACE, THEN A PULL WILL BE NOTICED IN THE PICTURE. THIS TROUBLE THEREFORE MUST BE CAUSED BY AN OPEN FILTER IN THE B+ CIRCUIT.

WITH A 120 CYCLE PULL IN THE PICTURE THE TROUBLE MUST BE IN THE POWER SUPPLY SINCE THIS IS THE ONLY PLACE IN A TV SET THAT HAS 120 CYCLES IN IT. IT SHOULD BE SIMPLE TO TELL IF THERE IS THIS CONDITION OCCURRING BECAUSE A CLOSE CHECK ON THE SIDE OF THE PICTURE WILL SHOW IF THERE ARE TWO VARIATIONS IN THE PULL FROM THE TOP OF THE PICTURE TO THE BOTTOM. IF ONLY ONE VARIATION IS NOTICED THEN THE TROUBLE MUST BE CAUSED BY A 60 CYCLE HEATER TO CATHODE SHORT.

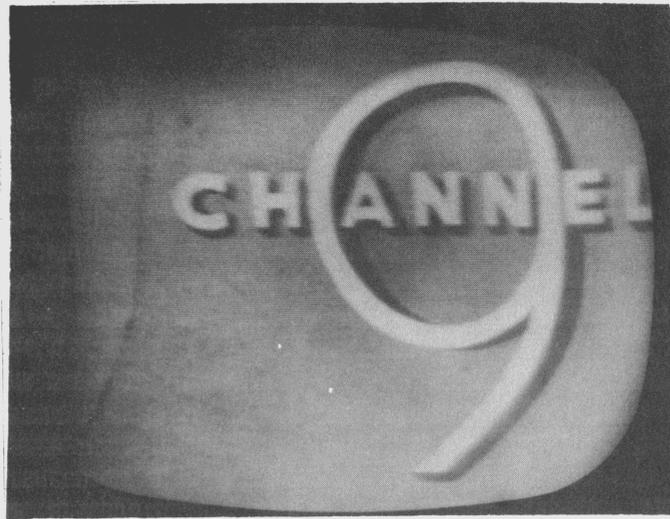
SELENIUM RECTIFIERS ARE MADE BY COATING A PLATE OF IRON WITH A LAYER OF SELENIUM AND PLACING A NUMBER OF THESE PLATES IN SERIES. IF THE CURRENT PASSING THROUGH THE PLATES IS SMALL ENOUGH FOR THE PLATES TO REMAIN COOL THEN THE RECTIFIER SHOULD LAST FOR MANY YEARS. IT IS ALWAYS ADVISABLE TO REPLACE A SELENIUM RECTIFIER WITH A LARGER CURRENT RATING THAN WAS USED IN THE SET, IF THE SPACE IS AVAILABLE, THAT IS, FOR EXAMPLE, A 250 MA CAN BE REPLACED WITH A 300 MA.

A LARGE NUMBER OF TV SETS TODAY ARE USING SELENIUM RECTIFIERS AS A MEANS OF OBTAINING THE LOW VOLTAGE. THIS IS A CHEAPER METHOD THAN THE USUAL 5U4G TUBE, AND WITH NORMAL CARE THE SELENIUM RECTIFIER SHOULD LAST THE LIFETIME OF THE SET. IN MOST CASES HOWEVER THE SELENIUM IS MISUSED IN THAT IT IS OFTEN PLACED UNDER THE CHASSIS WHERE THE MOST HEAT IS PRESENT, AND THE MILLIAMP RATING IS AT A MINIMUM. MOST COMMON TROUBLE IS LOW OUTPUT VOLTAGE CAUSING NOT ENOUGH WIDTH

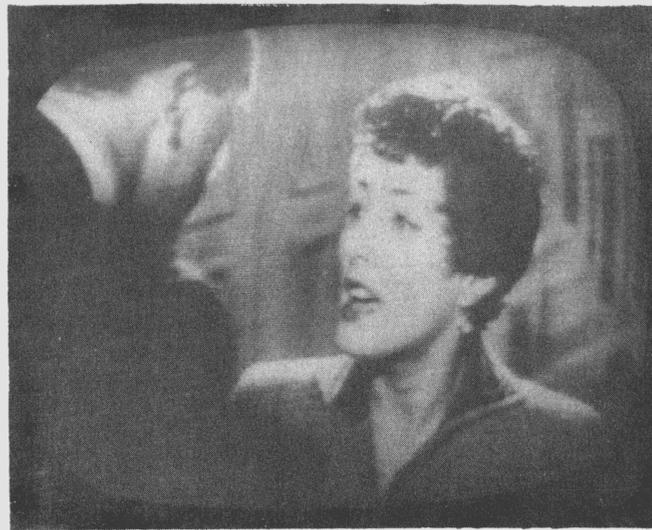
D I S T O R T I O N

DISTORTION WILL OCCUR IN THE SOUND CIRCUIT OF TV WHENEVER THE SOUND SIGNAL PASSES THROUGH A TUBE THAT HAS THE WRONG BIAS ON IT THIS WILL HAPPEN MOST OFTEN IN THE AUDIO AMP CIRCUIT SINCE THE BIAS ON THESE TUBES IS FAIRLY CRITICAL. IF THE IF CIRCUITS ARE OUT OF ALIGNMENT IT IS POSSIBLE THAT DISTORTION WILL OCCUR, HOWEVER IN MOST CASES POOR ALIGNMENT WILL CAUSE A BUZZ TO APPEAR IN THE SOUND. TUBES ARE THE MOST COMMON CAUSES OF THIS TROUBLE.

DISTORTION IN THE SOUND CIRCUITS OF A TV RECEIVER ARE THE SAME TROUBLES THAT CAUSE DISTORTION IN RADIO. THE ONLY DIFFERENCE IN THIS CASE IS THAT MANY TIMES THE DISTORTION IS DUE TO POOR ALIGNMENT. LEAKY COUPLING CAPACITORS AND BAD TUBES ARE BY FAR THE MOST COMMON TROUBLES HOWEVER AND SHOULD BE CHECKED. LOCAL OSCILLATOR ADJUSTMENTS MIGHT BE TRIED FIRST IF THEY ARE KNOWN BECAUSE THE TUNER MAY BE JUST A LITTLE OUT OF ADJUSTMENT. THE FINE TUNING MAY TELL YOU THIS IF VARIED.

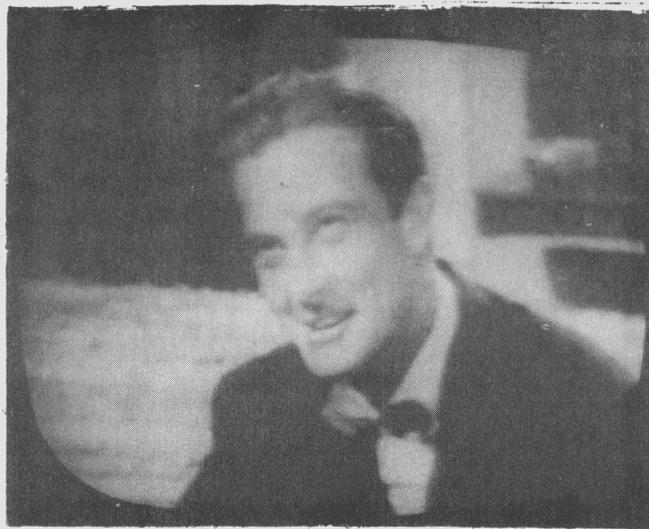
BUZZ IN THE SOUND HAS TWO COMMON CAUSES. ONE IS THE VIDEO IF TUBES BEING DRIVEN TO CUTOFF BY THE SIGNAL WHICH WOULD INDICATE SOME A. G. C. TROUBLE. THE OTHER BEING POOR ALIGNMENT WHICH WILL INTRODUCE A BUZZ IN THE SOUND SIGNAL. SOME CASES OF RADIATION FROM THE VERTICAL OUTPUT XFMR FEEDING INTO THE AUDIO AMPLIFIERS HAVE BEEN ENCOUNTERED BUT THIS IS NOT A COMMON TROUBLE. SOME OF THE TV SETS HAVE A BUZZ CONTROL ON THE BACK PANEL THESE SETS USE A 6BN6 AS A SOUND DETECTOR.

MANY TIMES IN A TV SET A BUZZ WILL BE HEARD IN THE SOUND. THERE ARE MANY CAUSES OF THIS CONDITION RANGING FROM ALIGNMENT TO TROUBLES AT THE STATION. CERTAIN STEPS MUST BE TAKEN TO LOCALIZE THIS TROUBLE TO ONE PARTICULAR STAGE OR CIRCUIT. IN THIS CASE THE FRONT PANEL CONTROLS ARE A GREAT HELP. FOR EXAMPLE IF THE VERTICAL HOLD CONTROL IS VARIED AND THE BUZZ INCREASES OR DECREASES IN PITCH, THEN THE TROUBLE IS RADIATION FROM THE VERTICAL CIRCUIT.

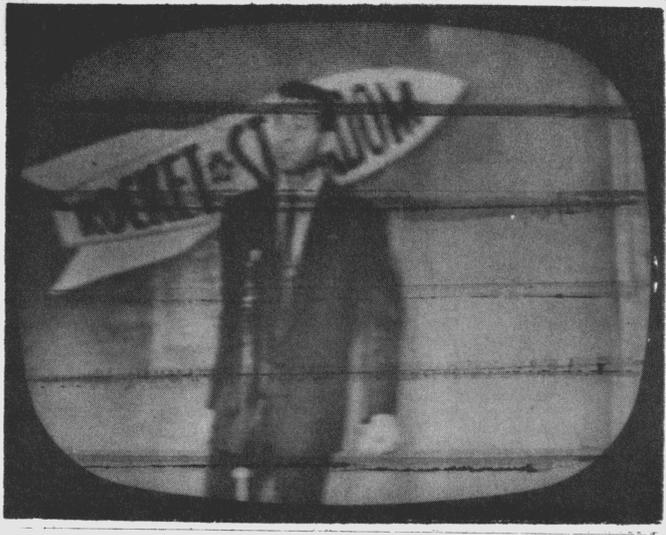
SOUND BARS IN THE PIX ARE CAUSED BY THE SOUND BEING PICKED UP IN THE VIDEO STRIP. MOST LIKELY CAUSE OF THIS IS AN OPEN FILTER CAPACITOR IN THE B + LINE THAT FEEDS THE AUDIO STRIP. THE POOR FILTERING THAT RESULTS WILL CAUSE THE SOUND TO FEED THROUGH INTO THE PIX. ANOTHER CAUSE OF THIS TROUBLE IS POOR ALIGNMENT IN THE SOUND CIRCUIT OR IN THE SOUND TRAPS THAT ARE LOCATED IN THE VIDEO STRIP. MISALIGNMENT OF THE LOCAL OSCILLATOR WILL ALSO GIVE SOUND BARS IN THE PIX.

SOUND IN THE PICTURE CAN BE RECOGNIZED BY THE BARS THAT APPEAR IN THE PIX AS THE SOUND IS BEING HEARD IN THE SPEAKER. IN A NUMBER OF CASES THE SOUND BARS WILL APPEAR AS THE VOLUME CONTROL IS INCREASED. OTHER CASES WILL SHOW SOUND BARS WITH JUST A VERY LOW SETTING OF THE VOLUME. BOTH CASES HOWEVER INDICATE THAT THE SOUND IS BEING PICKED UP IN THE VIDEO AMPS AND BEING PASSED TO THE C. R. T. THE TROUBLE ITSELF SHOULD NOT BE CONFUSED WITH 4.5 MC INTERFERENCE WHICH SHOWS UP AS A FINE GRAIN PATTERN ON THE SCREEN.
