No. 4 ESS:

Performance Objectives and Service Experience

By E. A. DAVIS and P. K. GILOTH

The development plan of the No. 4 ESS included provisions for measuring the effectiveness of the design, operation, maintenance, and administration of the total system. This paper reviews system performance from 1976 to 1980, describes principal factors affecting system performance, and presents the service experience measured for the No. 4 ESS. Steady improvement has been measured in the number of service-affecting incidents experienced per office each month. This improvement is also reflected in the rate of cutoff and denied calls, as well as in system "no call processing" time. We discuss some of the factors influencing this performance record, e.g., a sound initial design, reliable hardware, effective maintenance and repair tools, continuing analysis and resolution of causes of service-affecting incidents, and continuing development of new features for performance improvement.

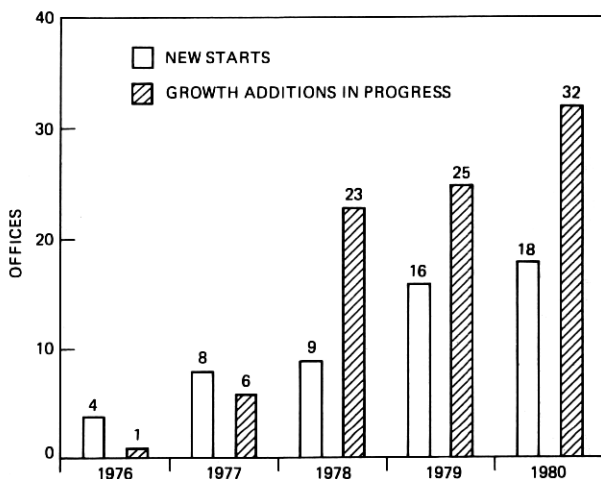
Fig. 4—Trend in No. 4 ESS growth activity.

The rate of growth additions to existing No. 4 ESS systems has increased steadily. Figure 4 shows the number of major growth jobs in progress and the number of new No. 4 ESS offices placed in service during each year since 1976. Nearly two-thirds of the operational No. 4 ESS systems have been expanded with growth jobs. Through the end of 1979, growth activity had added over 900 frames of ESS equipment and provided over 350,000 new terminations, or nearly one-third of all installed No. 4 ESS terminations. Several offices have been expanded

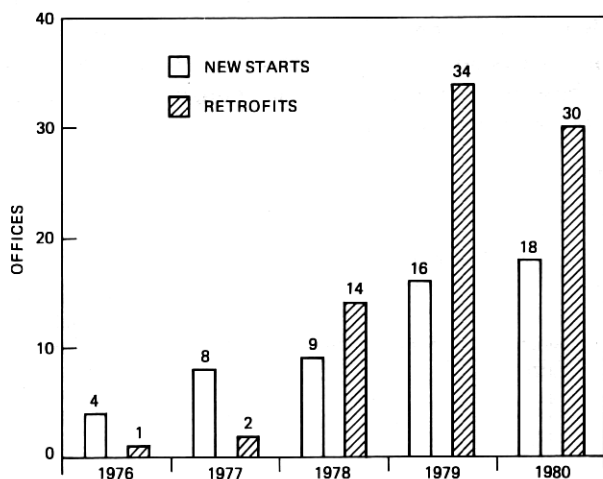
Fig. 6—Trend in No. 4 ESS retrofit activity.

which each No. 4 ESS replaces its current generic program with the latest generic. Current plans call for each office to receive the new generic within a year of its official release. Figure 6 shows the number of retrofits each year since 1976, indicating a large increase as new offices have been added.
